## EFFECTS OF REINFORCEMENT CONFIGURATION ON RESERVE CAPACITY OF CONCRETE SLABS

Structures Laboratory

Federal Emergency Management Agency Washington, DC 20472

### TECHNICAL REPORT SL-85-5

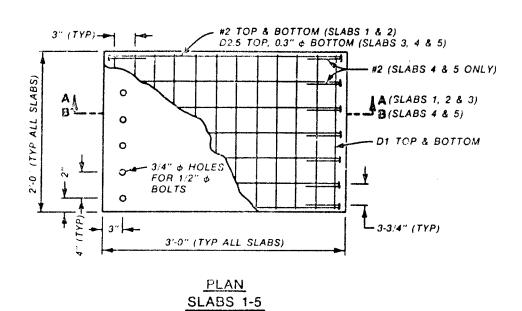
Figure 2.1. Plan details for roof slabs (Sheet 1 of 4).

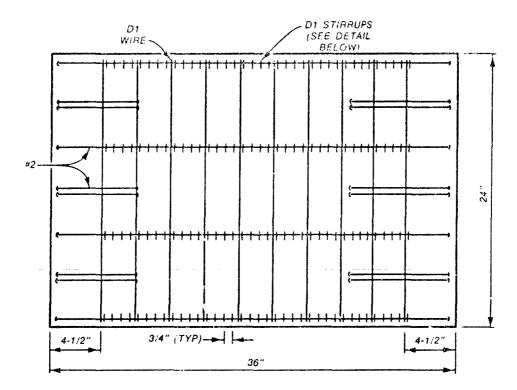
Figure 2.17. Stirrup details, Slabs 9-12.

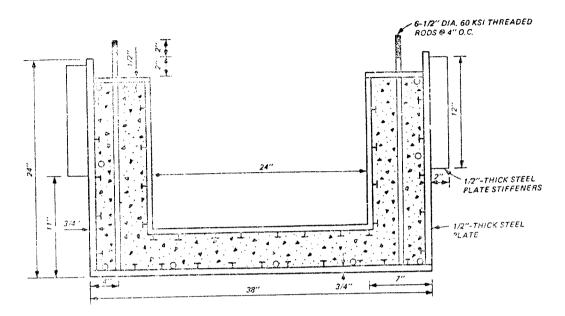
Figure 2.18. Cross section of reaction structure.

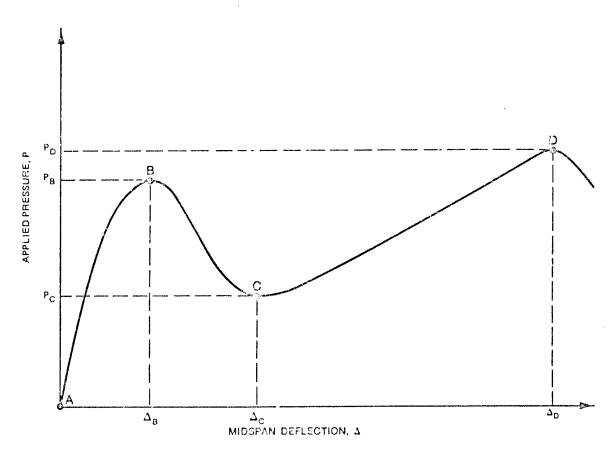
Figure 4.1. Load-deflection relationship for one-way slabs with restrained ends.

The flexural strength of a restrained slab is enhanced by compressive membrane forces, causing the ultimate load to be greater than that calculated using yield-line theory. Ultimate pressure considering compressive membrane forces is represented by Point B of Figure 4.1. At the end of compressive membrane action, center cracks penetrate the entire thickness of the slab, and the reinforcing bars act as a tensile membrane to support the load. In Figure 4.1 the tensile membrane region extends from Point C to Point D, which represents incipient collapse.

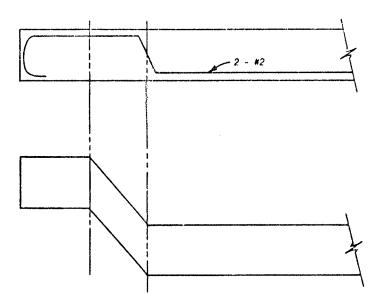
Figure 4.3. Four-hinge failure mechanism.

- 1. A three-hinge mechanism, with deep cracks over the supports, crushing of concrete in the center and, with the exception of Slab 3, 100 percent of midspan bottom reinforcing broken.
- 2. A modified three-hinge mechanism, with cracking at the supports extending in an almost circular pattern from the center of the support to the center of the unsupported edges and a central hinge occurring over a large (and often not clearly defined) area. Although badly bent and elongated, some midspan bottom reinforcing remained unbroken.
- 3. A four-hinge mechanism with no reinforcing broken, but considerable crushing of concrete. The four-hinge failure mechanism is shown in detail in Figure 4.3.

## 4.3.3 Four-Hinge Failure Mechanism

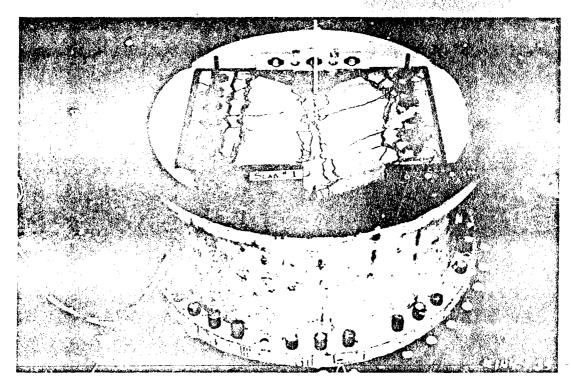
Figure 4.4. Slab 1, posytest.

- 4.3.1.1 Slabs 1 and 2. Complete midspan cracking and crushing through the slab thickness occurred over about one-fourth of the width in Slab 1 (Figures 4.4 and 4.5) and throughout the entire width in Slab 2 (Figures 4.6 and 4.7). Very little cracking occurred outside of the hinge areas.
- 4.3.1.2 Slab 3. The edge bottom reinforcing bars did not rupture at midspan, and there was some cracking above the edge bars throughout the length of the slab (Figures 4.8 and 4.9). The concrete was cracked and crushed at

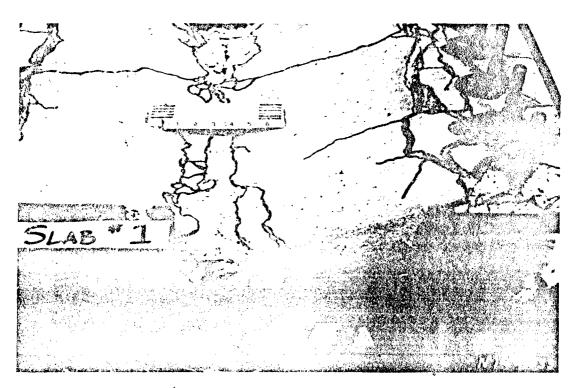
Figure 4.5. Closeup view of Slab 1, posttest.

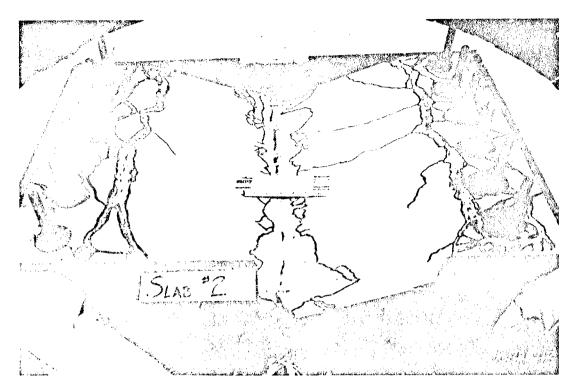
Figure 4.6. Slab 2, posttest.

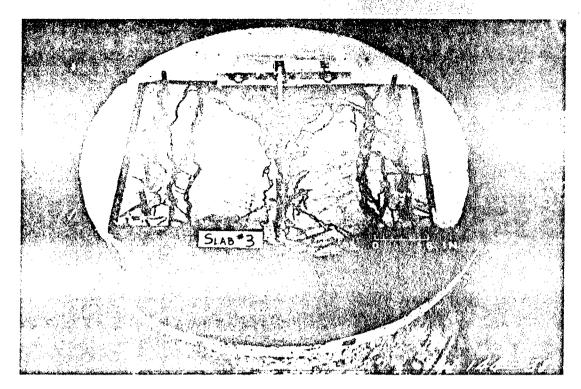
Figure 4.8. Slab 3, posttest.

midspan through the entire thickness of the slab. Most top reinforcing at the supports was broken.

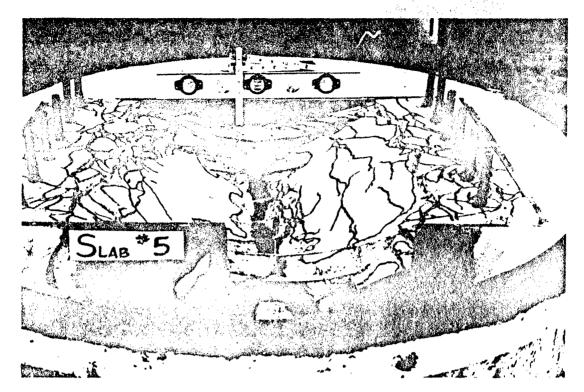
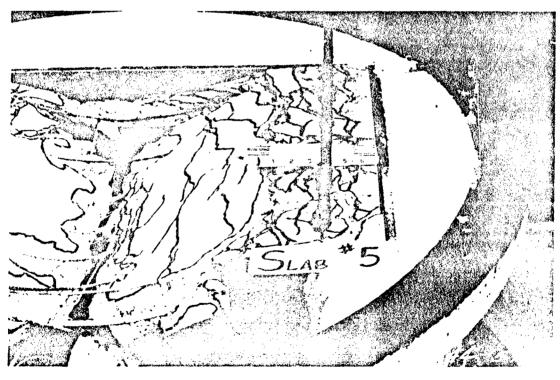
Figure 4.10. Slab 4, posttest.

Figure 4.11. Closeup view of Slab 4, posttest.

Figure 4.12. Slab 5, posttest.

Figure 4.13. Closeup view of Slab 5, posttest.

- 4.3.2 Modified Three-Hinge Failure Mechanism
- 4.3.2.1 Slabs 4 and 5 (Figures 4.10-4.13). Reinforcement was similar to Slab 3, except that dowels were added in the tensile region over the supports. Both slabs were crushed throughout the thickness at midspan. Few top reinforcing bars were broken at the supports, and no top reinforcing was broken at midspan. Much of the bottom steel was broken at midspan.

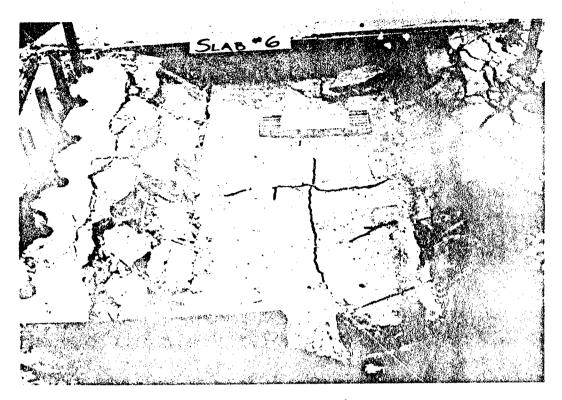
Figure 4.16. Closeup view of Slab 6 following retest.

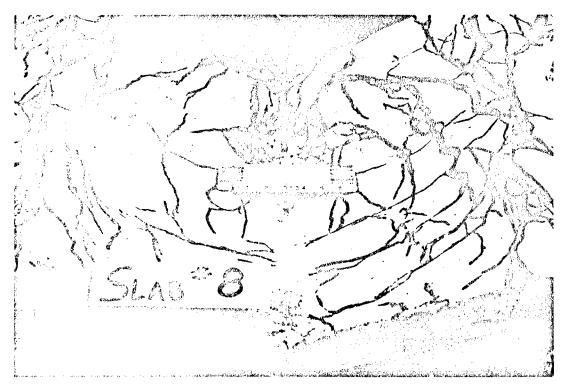
Figure 4.18. Slab 8, posttest.

Figure 4.19. Closeup view of Slab 8, posttest.

Slabs 7 (Figure 4.17) and 8 (Figures 4.18 and 4.19) behaved similarly, with few top bars broken at the supports, 40 to 60 percent of bottom reinforcing broken at midspan, and no compressive steel broken. Failure was clearly by Mode 2.

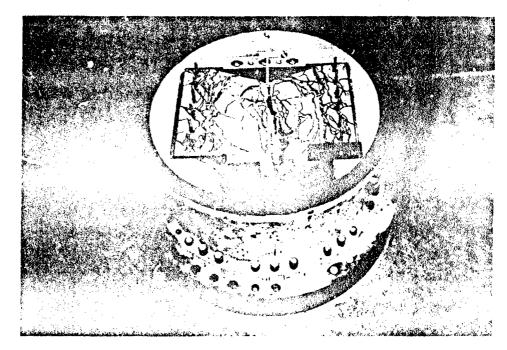
Figure 4.20. Slab 9, posttest.

Figure 4.21. Closeup view of Slab 9, posttest.

Slabs 9 (Figures 4.20 and 4.21) and 12 (Figures 4.26 and 4.27) had areas of crushing outside the central hinge, suggesting that at some points an additional hinge was formed. Slabs 9 and 12 were more heavily instrumented with strain gages and accompanying wiring than Slabs 10 or 11, perhaps affecting the cracking pattern.

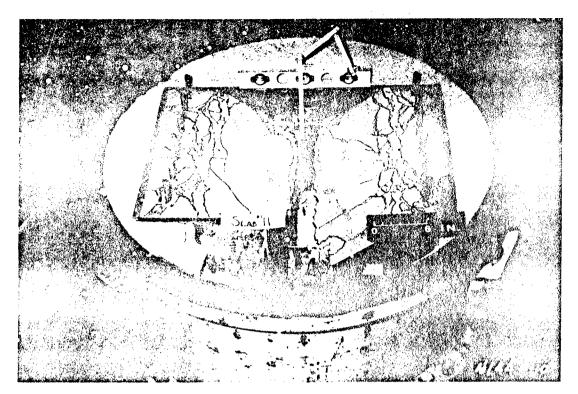
Figure 4.24. Slab 11, posttest.

Figure 4.25. Closeup view of Slab 11, posttest.

- 4.3.1.3 Slab 11. The concrete was completely crushed throughout the center, but few cracks occurred outside of the hinge areas (Figures 4.24 and 4.25). Much of the top reinforcing was broken, both at midspan and over the supports.

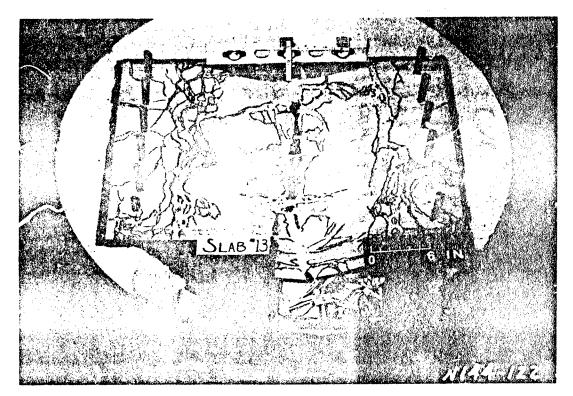
Figure 4.28. Slab 13, posttest.

Slab 13 was badly cracked throughout the length of the span (Figure 4.28)

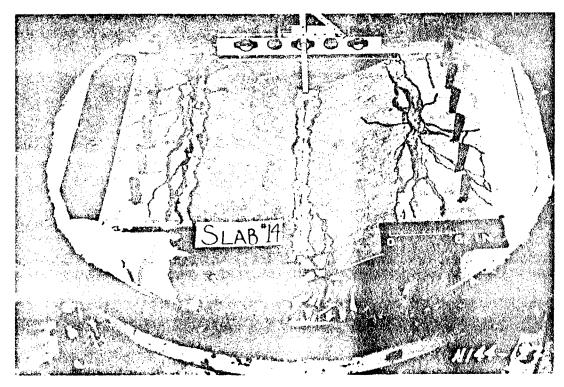
Figure 4.29. Slab 14, posttest.

- 4.3.1.4 Slab 14. Slab 14 failed in a classic three-hinge mechanism, with 100 percent of tensile reinforcing broken and almost no cracking between hinges (Figure 4.29). There were small gaps in the concrete at midspan where crushing occurred throughout the slab thickness.

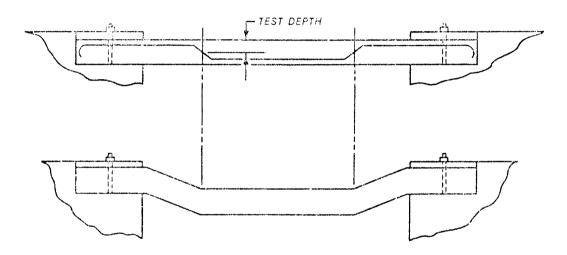
Figure 5.1. Four-hinge failure mechanisms induced by reinforcing pattern.

The experimental capacity for Slab ( was much lower than expected due to the four-hinge failure mechanisms induced by the reinforcing pattern (Figure 5.1). Interior hinges formed near the center of the diagonal section of rebar between bends, resulting in a reduced depth of section and reduced capacity

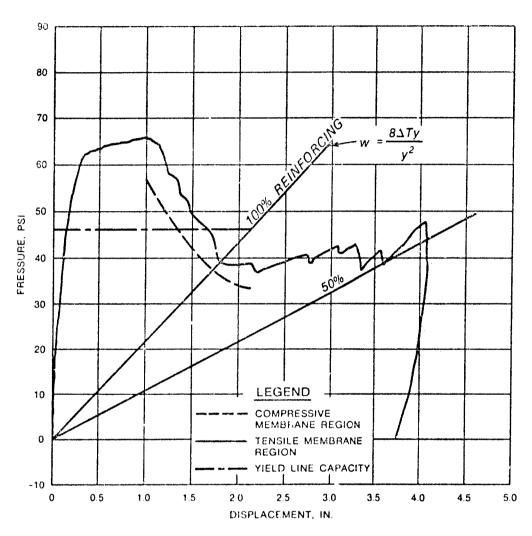
Figure 5.2. Predicted and actual resistance curves, Slab 1.

Slab 6 was the only slab that exhibited predictable tensile membrane behavior. Because of the reinforcement arrangement and the four-hinge failure mechanism, Slab 6 was able to carry large loads with relatively little deflection, and no reinforcing was ruptured. Predicted tensile membrane capacity was conservative, probably due to the neglect of reinforcement strain hardening. Predicted and actual resistance curves for Slabs 1, 3, 6, and 8 are shown in Figures 5.2 through 5.5.

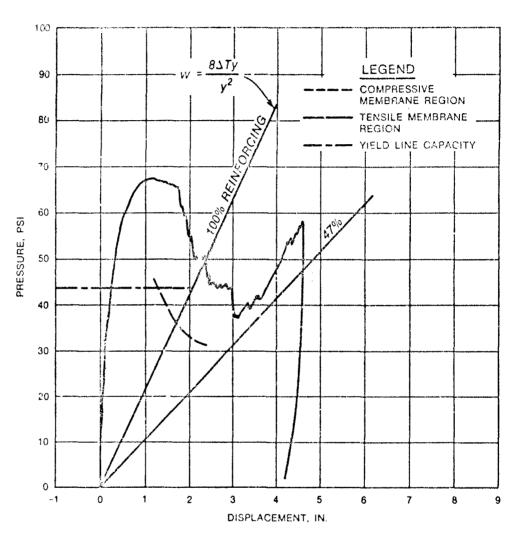
Figure 5.3. Predicted and actual resistance curves, Slab 3.

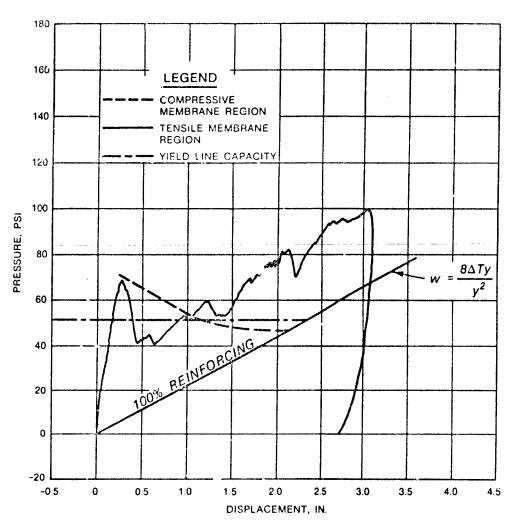
Figure 5.4. Predicted and actual resistance curves, Slab 6.

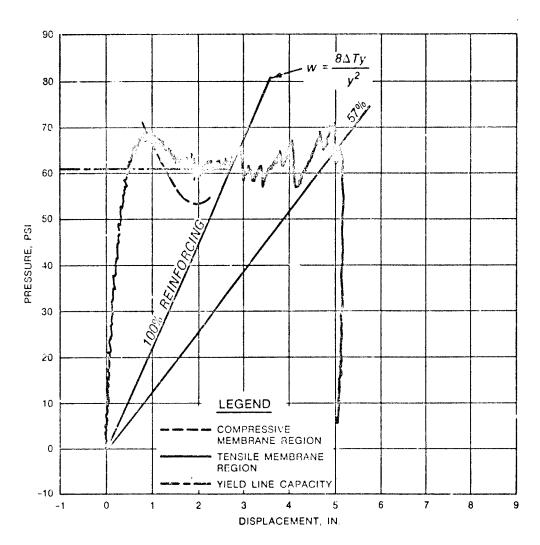
Figure 5.5. Predicted and actual resistance curves, Slab 8.

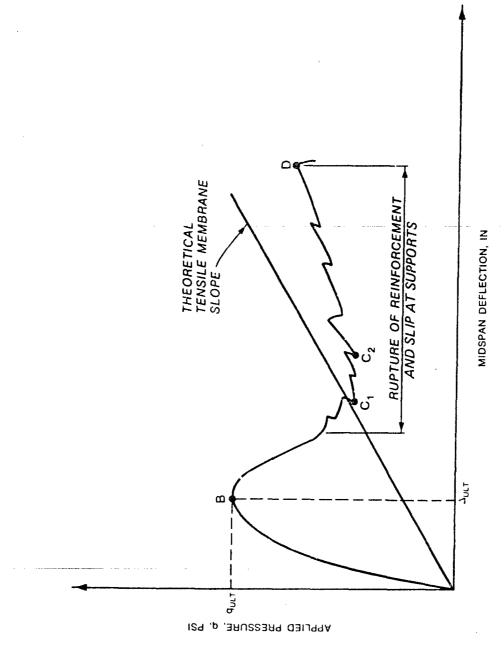
Figure 5.6. Revised load-deflection relationship.

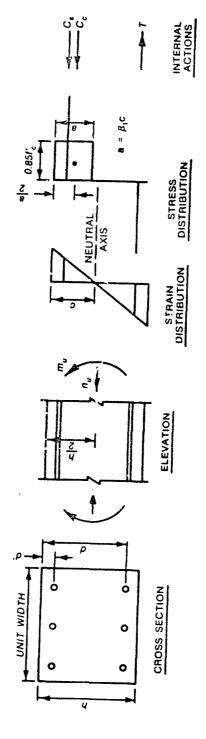
Figure B.3. Conditions at a positive moment yield section.
